[Docket No. FAA-2011-0054; Directorate Identifier 2010-CE-070-AD; Amendment 39-16582; AD 2011-01-53]

Airworthiness Directives; PIAGGIO AERO INDUSTRIES S.p.A Model PIAGGIO P-180 Airplanes

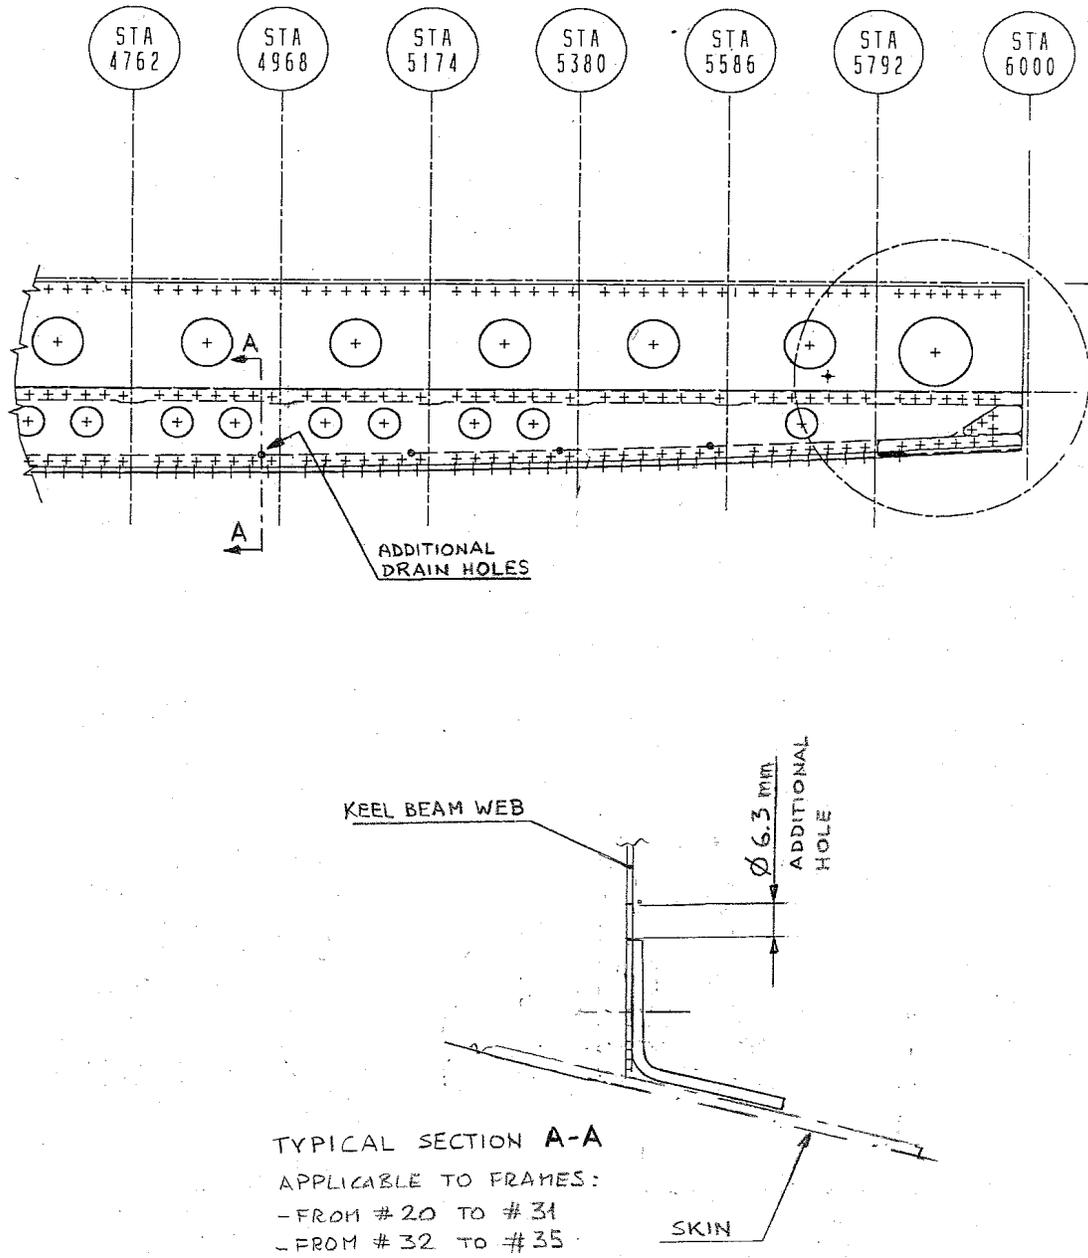
Figure 1. Additional drain holes on keel beam webs

- c. Evaluate the amount of fluid collected:
 - i. If water is found only in the bottom of the belly (i.e., undrainable within the keel beams), go to step 6. Step 5 does not need to be accomplished at this time.

- ii. If water is found in excess of item above (4-c-i), do step 5.
5. Add 6.3 mm draining holes as per attached figure 1 (additional drain holes on keel beam webs) connecting the lateral bays to the center ones or, as alternative, apply Piaggio Aero Industries Service Bulletin 80-0291. Then proceed with step 6.
