SAIB: CE-11-57

Date: September 14, 2011

SUBJ: Powerplant, Engine Mount Section

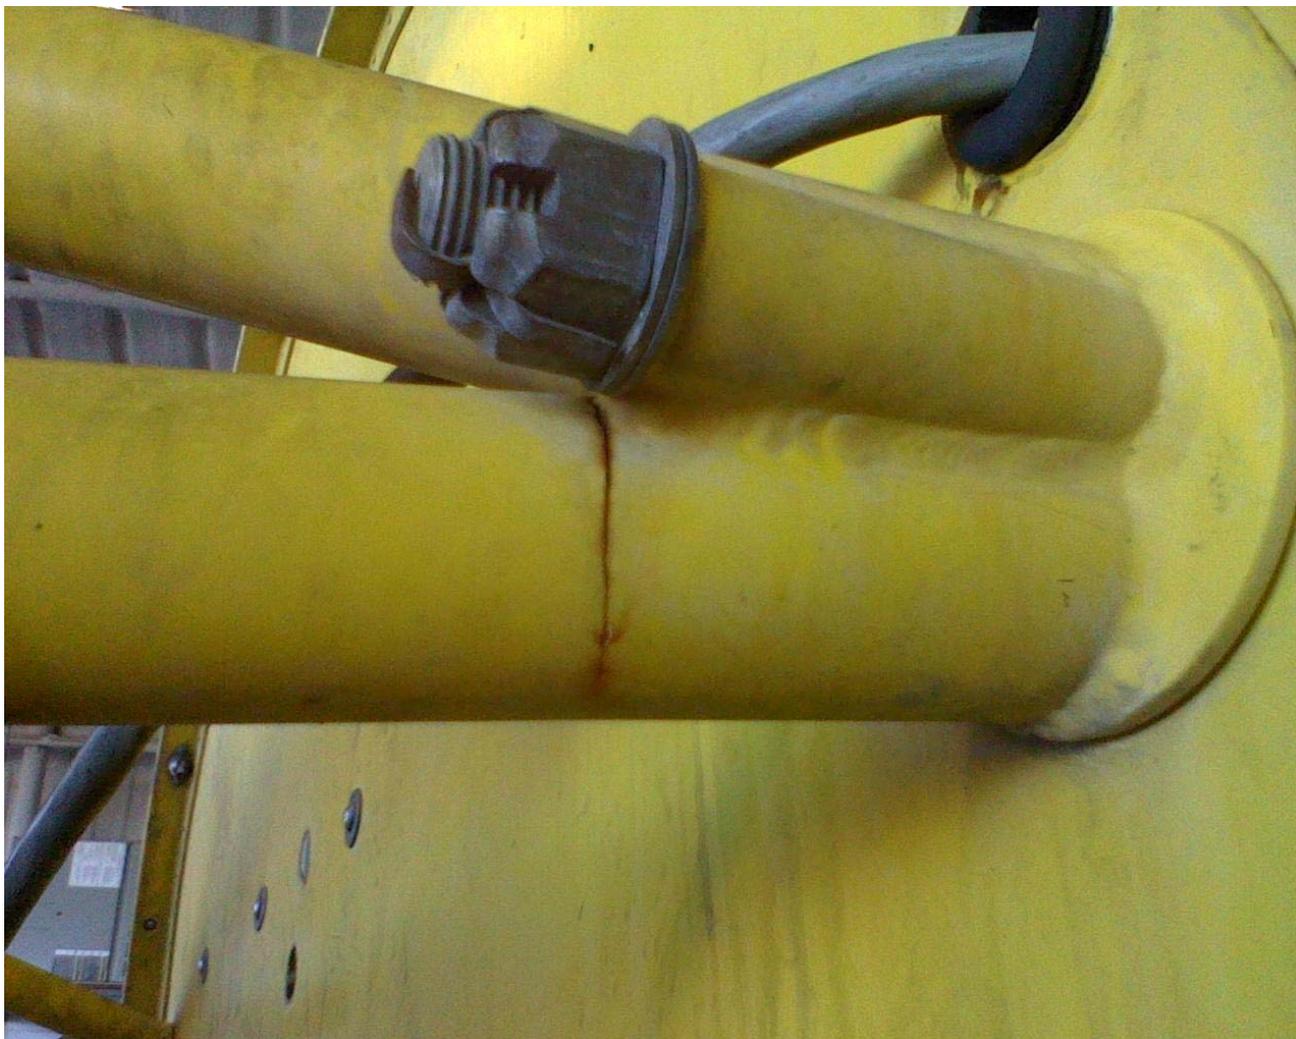
The Federal Aviation Administration (FAA) received a report of a fatigue crack in a Model AT-402 airplane engine mount tube at the left hand firewall attach location. The crack started in the tip of the weld where the tubes intersect at the attach bolt lug location (see photo below). This crack area is separate from the engine mount area required to be inspected by AD 2009-11-05 effective on June 1, 2009.

Left unaddressed, cracks can continue around the perimeter of the engine mount attach tube and result in loss of connection of the attach tube at the firewall, leading to reduction in structural integrity.

In response Air Tractor, Inc. issued Snow Engineering Co. Service Letter #297 directing recurring visual inspections of the right and left hand engine mount attach tubes at the firewall, focusing on where the tubes join at the weld tip. The first inspection is performed before continued flight, with recurring inspections at each annual inspection thereafter. Contact the Air Tractor, Inc. Service Department if any cracks are found to obtain a repair or replacement method prior to continued flight.

The FAA recommends that all owners and operators of Air Tractor, Inc. Models AT-400, AT-400A, AT-402, AT-402A, and AT-402B airplanes inspect the engine mount attach tubes at the time intervals and using the inspection procedures directed in Snow Engineering Co. Service Letter #297. Repair or replace any engine mount found cracked during any inspection in accordance with Air Tractor, Inc. Service Department instructions prior to continued flight.
