SUBJ: Wings - Piper PA-28, PA-32, PA-34, and PA-44 Corrosion on Flap Hinges, Brackets, and Ribs **SAIB: CE-11-10**
Date: January 5, 2011

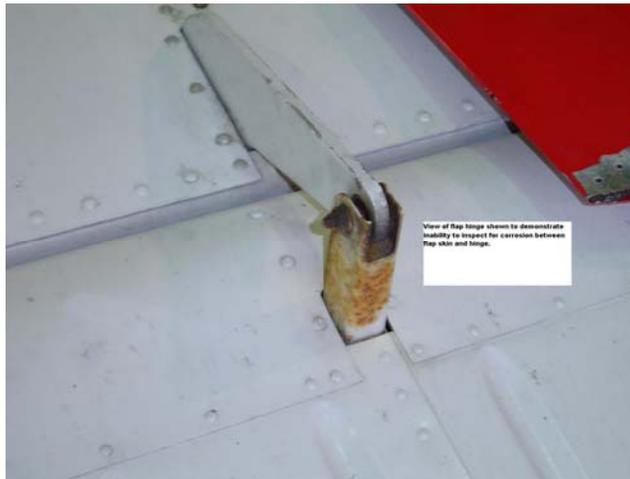
Figure 1

This information is presented in response to service data showing corrosion on the flap hinge and flap ribs of Piper PA-28 and PA-34 aircraft. Affected part numbers are 62324-xx (hinge), 62328-xx (rib), 62323-00 and 65899-00 (brackets). See Figures 1 and 2 below as examples. There were nineteen (19) occurrences found during routine maintenance over a 12-year period, with an average in-service time of 3,200 hours. There is one related major flap failure incident from 2002 that resulted in no injuries or fatalities. Note: The steel brackets and aluminum ribs are common to all PA-28, PA-32, PA-34, and PA-44 aircraft.

The FAA recommends that owners and operators increase their focus on the inspections provided in Piper’s service manuals or progressive inspection manuals for the PA-28, PA-32, PA-34, and PA-44 related to the flap brackets, hinges, and ribs. We strongly recommend increased detail inspection for those aircraft at higher risk due to age, environment, lack of protective coatings, etc., discussed above.

If damage is found, a Malfunction / Defect Report or Service Difficulty Report (SDR) should be filed. The SDR system is available at <http://av-info.faa.gov/sdrx/>. There are currently no established allowable limits on the subject parts so repair or replacement will be necessary if damage is found.
