SUBJ: Wings - Piper PA-28, PA-32, PA-34 Forward Spar Corrosion **SAIB: CE-11-13**
Date: January 5, 2011

Introduction

This Special Airworthiness Information Bulletin (SAIB) alerts you, owners and operators of **all Piper Aircraft, Inc. PA-28, PA-32 and PA-34 models**, of potential corrosion on the wing front spar at the fuselage attach fitting, at the landing gear attach point, and behind the leading edge fuel tank. This also alerts you of our recommendation to incorporate Piper Service Bulletin (SB) 1006 as mitigating action.

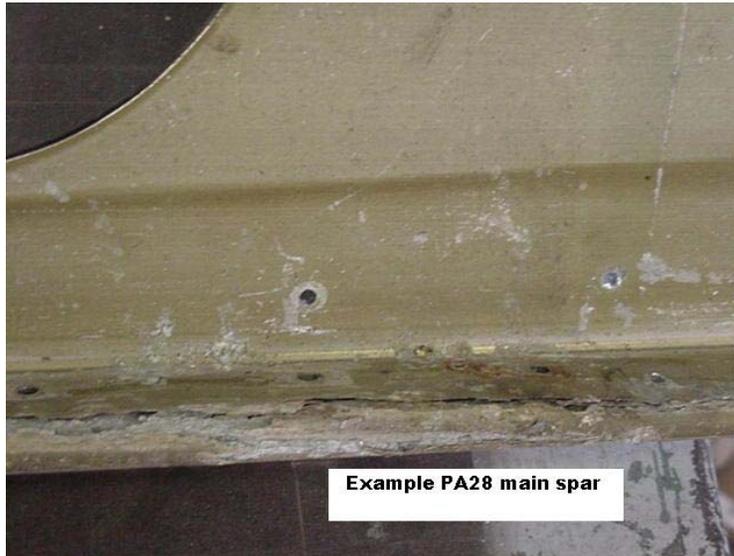
This information is presented in response to service data showing extensive corrosion on the wing front spar at the fuselage attach fitting, at the landing gear attach point, and behind the leading edge fuel tank of Piper PA-28 and PA-32 aircraft. See Figure 1 as an example. Due to similarity of design, the PA-34 is also susceptible to this corrosion. Note: The landing gear attach point configuration will vary, particularly between the fixed and retractable gear models. An example of the area of concern for the landing gear attachment is where the bracket Piper part number 95643-06 / -07 attaches to the front spar on the PA-28R aircraft.

The FAA recommends that owners and operators incorporate the actions in Piper SB 1006 based on the effectivity of the SB. Due to similarity of design (steel components mating to aluminum spar) and since improper maintenance or painting procedures have been a contributing factor in past service reports, all PA-28, PA-32, and PA-34 aircraft are susceptible to this corrosion development. Therefore, the inspections in the SBs should be implemented for all PA-28, PA-32, and PA-34 models. We recommend that all the actions be taken within 100 hours. We further recommend inspection and incorporation as soon as feasible, but no more than 100 hours, for those aircraft at higher risk due to age, environment, lack of protective coatings, etc., as discussed above.

If damage is found, a Malfunction / Defect Report or Service Difficulty Report (SDR) should be filed. The SDR system is available at <http://av-info.faa.gov/sdrx/>. There are currently no established allowable limits on the subject parts so repair or replacement will be necessary if damage is found.
