SAIB: CE-11-21

Date: February 16, 2011

SUBJ: Flight Controls: Trailing Edge Flaps; Flap Nose Rib Cracking

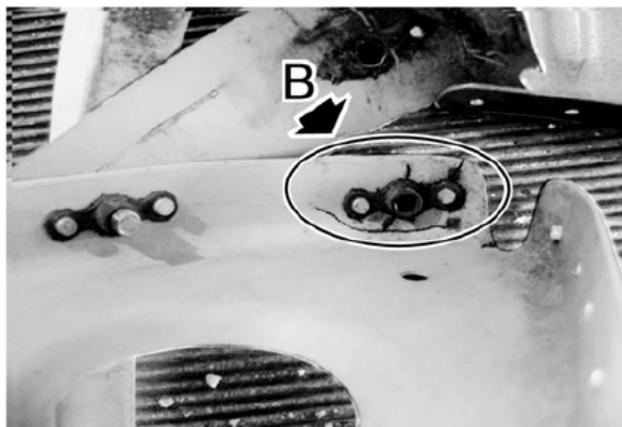
In 2007, a pilot reported a split flap condition during flap extension and landed safely without incident. Inspection of the airplane by a 14 CFR part 145 repair station found the right-hand (R/H) flap rod attach bracket broken and the flap nose rib nut plate flange torn. Further inspection of the flap revealed cracking in the P/N 35-165050-84 nose rib. Inspection of the left-hand (L/H) side flap found similar damage. Six other airplanes were inspected by the repair station and found similar cracking to the P/N 35-165050-84 nose rib. Service difficulty reports were submitted for Hawker Beechcraft Models 35, 36, 55, and 95 aircraft in November 2007 and were published in Advisory Circular 43-16A, Aviation Maintenance Alerts, dated January 2008. These aircraft had flight hours between 4,000 and 6,500 hours. Similar reports of damage have been identified on airplanes with as few as 2,000 flight hours. Nose ribs of both the L/H and R/H flaps are prone to cracking. It is unknown at this time the exact cause of the cracking. See Figure 1 for examples of cracks in the P/N 35-165050-84 nose rib.

Example of Crack in P/N 35-165050-84 Nose Rib

- Pay particular attention to this area during pre-flight inspections.
- Inspect the up-stop bumper for proper rigging and nose rib for cracks during the annual inspection.
- Since the R/H flap nose rib assembly is located in close proximity to the wing walk area, it is recommended to avoid stepping on the flap to reduce the stress on the nose rib.

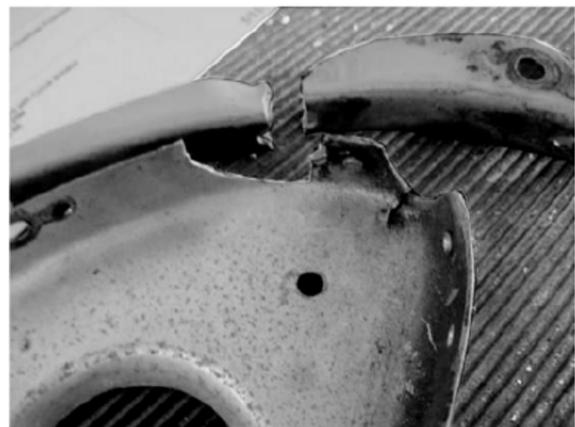
Example of Torn Flange in P/N 35-165050-84 with Nutplate Missing
